## milwaukee RIVERKEEPER®

# 2016 Milwaukee River Basin Report Card

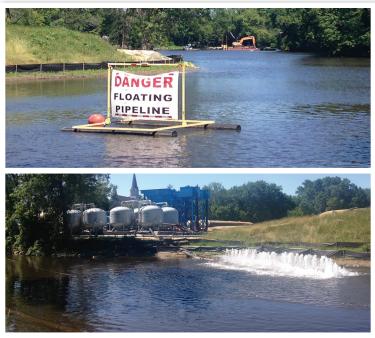
PCB removal in Cedar Creek from Columbia Pond.

confluence with the Milwaukee River. Mercury Marine cleaned up contaminated sediments from the Ruck Pond Raceway, and also cleared portions of Cedar Creek Park and an adjoining church to serve as a temporary staging area for sediment removal of the downstream ponds. Plans for cleaning up the Creek below the Wire & Nail Pond, which is largely all in private hands, are still in development. Following the remediation, the Creek and affected adjoining properties will be restored to more natural conditions in cooperation with landowners.

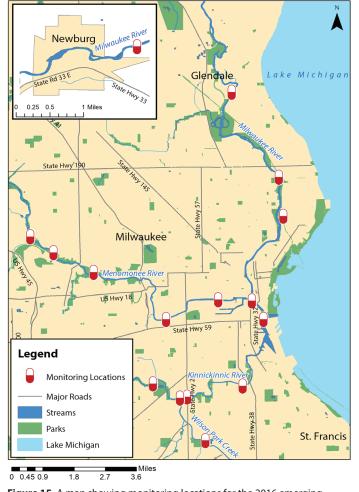
### Emerging Contaminants Monitoring Locations

**Figure 15.** A map showing monitoring locations for the 2016 emerging contaminants monitoring.
